Manhole Inspection Summary

Manhole # S1500_011MH

Location Address: **2631 GWYNNS FALLS PKWY** Cross Street: **EVERGREEN ST**

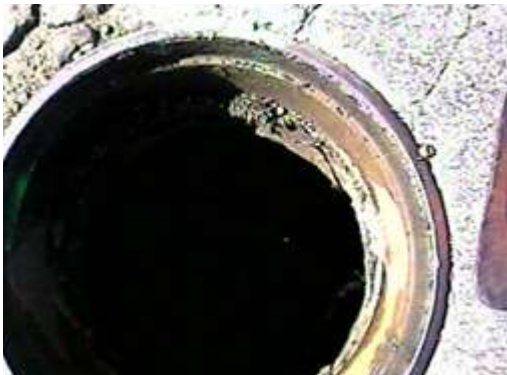
Top View

Frame Offset: **3** (in.) Condition: ☒ Sound ☐ Cracked ☐ Leaks

FRAME OFFSET

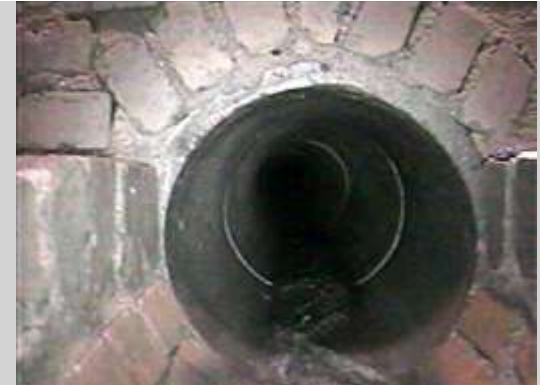
12 O'Clock Outflow

12 in. Circular Gravity Sewer
Pipe Out @ 12 O'Clock

Pipe Material: **Clay** ☐ Pipe Lined

Invert Depth: **8.06** (ft.) Flow Characteristics: **Slow**

Deposits: ☒ None ☐ Mud ☐ Sludge ☐ Debris ☐ Grease

Infiltration: **None** Pipe Seal Cond: **Sound**

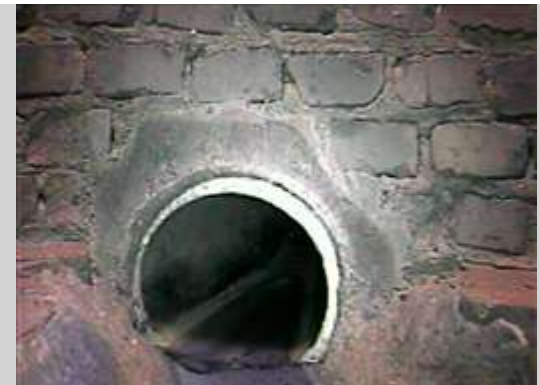
3 O'Clock Inflow

8 in. Circular Gravity Sewer
Pipe In @ 3 O'Clock

Pipe Material: **Clay** ☐ Pipe Lined

Invert Depth: **7.68** (ft.) Flow Characteristics: **None**

Deposits: ☒ None ☐ Mud ☐ Sludge ☐ Debris ☐ Grease

Infiltration: **None** Pipe Seal Cond: **Sound**

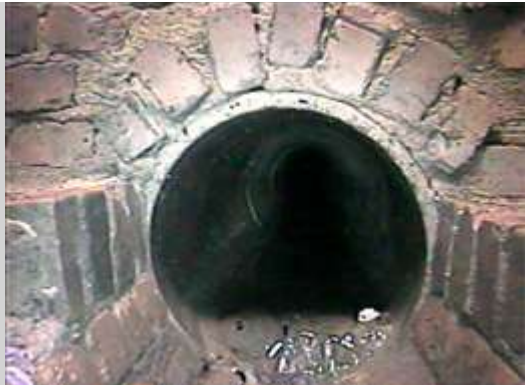
6 O'Clock Inflow

12 in. Circular Gravity Sewer

Pipe In @ 6 O'Clock

Pipe Material: **Clay** ☐ Pipe Lined

Invert Depth: **8.03** (ft.) Flow Characteristics: **Slow**

Deposits: ☒ None ☐ Mud ☐ Sludge ☐ Debris ☐ Grease

Infiltration: **None** Pipe Seal Cond: **Sound**

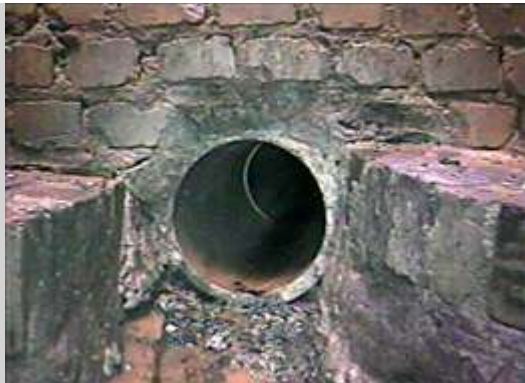
9 O'Clock Inflow

8 in. Circular Gravity Sewer

Pipe In @ 9 O'Clock

Pipe Material: **Clay** ☐ Pipe Lined

Invert Depth: **7.96** (ft.) Flow Characteristics: **None**

Deposits: ☒ None ☐ Mud ☐ Sludge ☐ Debris ☐ Grease

Infiltration: **None** Pipe Seal Cond: **Sound**
